ABRASION/EROSION IN STILLING BASINS

Leslie Hanna and Elisabeth Cohen
Bureau of Reclamation, Denver, Colorado, USA

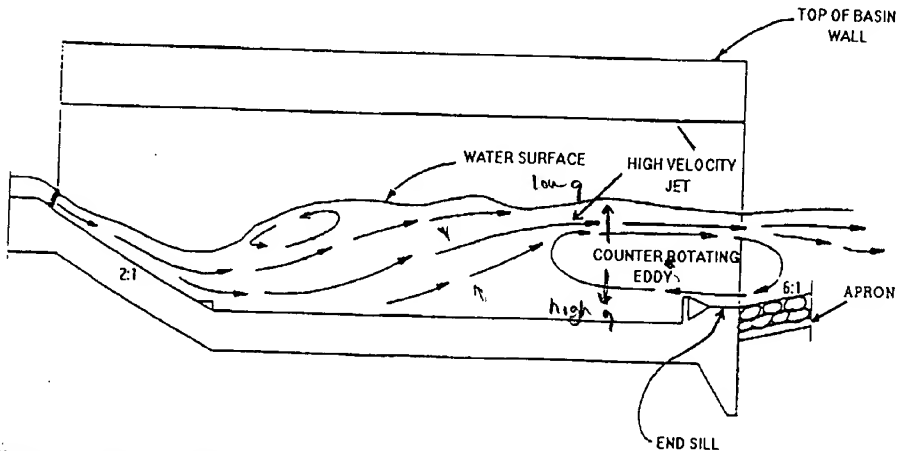
Many stilling basins have experienced damage caused by rock, gravel, and sand brought into the basin by back flow over the stilling basin end sill. Normal operation of a hydraulic jump energy dissipation basin can cause a reverse flow eddy over the basin end sill and lower apron as shown in figure 1. This counter-rotating eddy is driven by a high velocity jet rising off the basin floor near the end of the basin. Riprap placed on the apron downstream of the basin end sill is typically designed to be stable under this condition. However, small material can be transported into the basin and trapped where turbulent flow continually moves the material about the surface, eroding the concrete. The cost for these repairs, in terms of time, effort and money, can be significant. If a means to reduce the reverse flow can be found, large savings can be obtained. One possible solution that is currently being studied at the Bureau of Reclamation's Water Resources Research Laboratory (WRRL) is to install flow deflectors in the basin to improve inter-basin flow conditions and minimize upstream velocities over the basin end sill (figure 2).

Figure 1. Counter-rotating flow eddy over basin end sill and lower apron.
